Manhole Inspection Summary

Manhole # S39EE1001MH

Insp Date: **1/16/07 9:49 AM**

Location Address: **619 PARKWYRTH AVE**

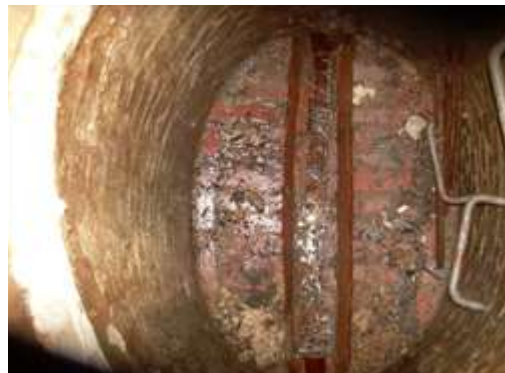
Top View

Bench debris.

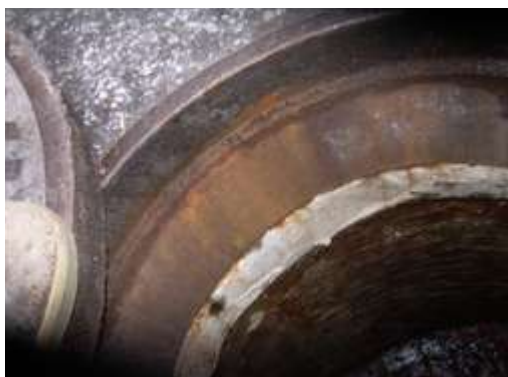
Defect

Frame Offset: **0** (in.) Condition: ☐ Sound ☐ Cracked ☒ **Leaks**

Infiltration: ☐ None ☒ **Joint** ☐ Cracks ☐ Mortar ☐ Roots ☒ **Wall**

Frame leaks. Adjustment infiltration.

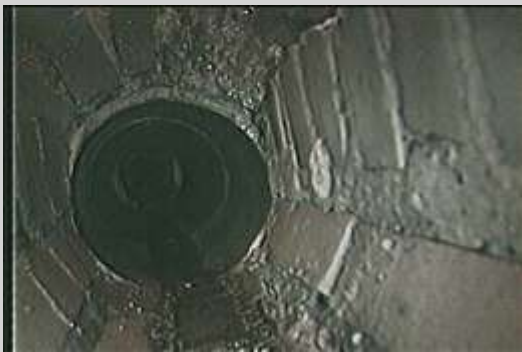
8 in. Circular Gravity Sewer Pipe Out @ 12 O'Clock

Infiltration: **None** Pipe Seal Cond: **Unknown**

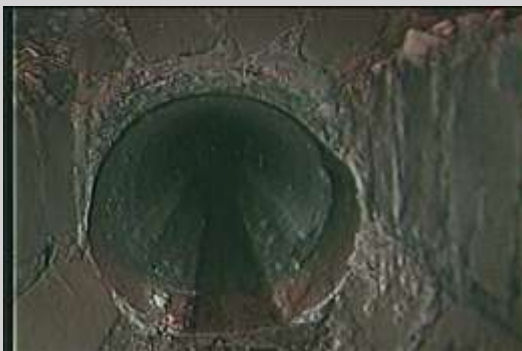
8 in. Circular Gravity Sewer Pipe In @ 5 O'Clock

Infiltration: **Evidence** Pipe Seal Cond: **Unknown**
